Fairgreen BESS

British Standards 5837:2012 Tree
Survey: Arboricultural Impact
Assessment, Method Statement and
Tree Protection Plan

RSE_9244_R1_V3_ARB

June 2025

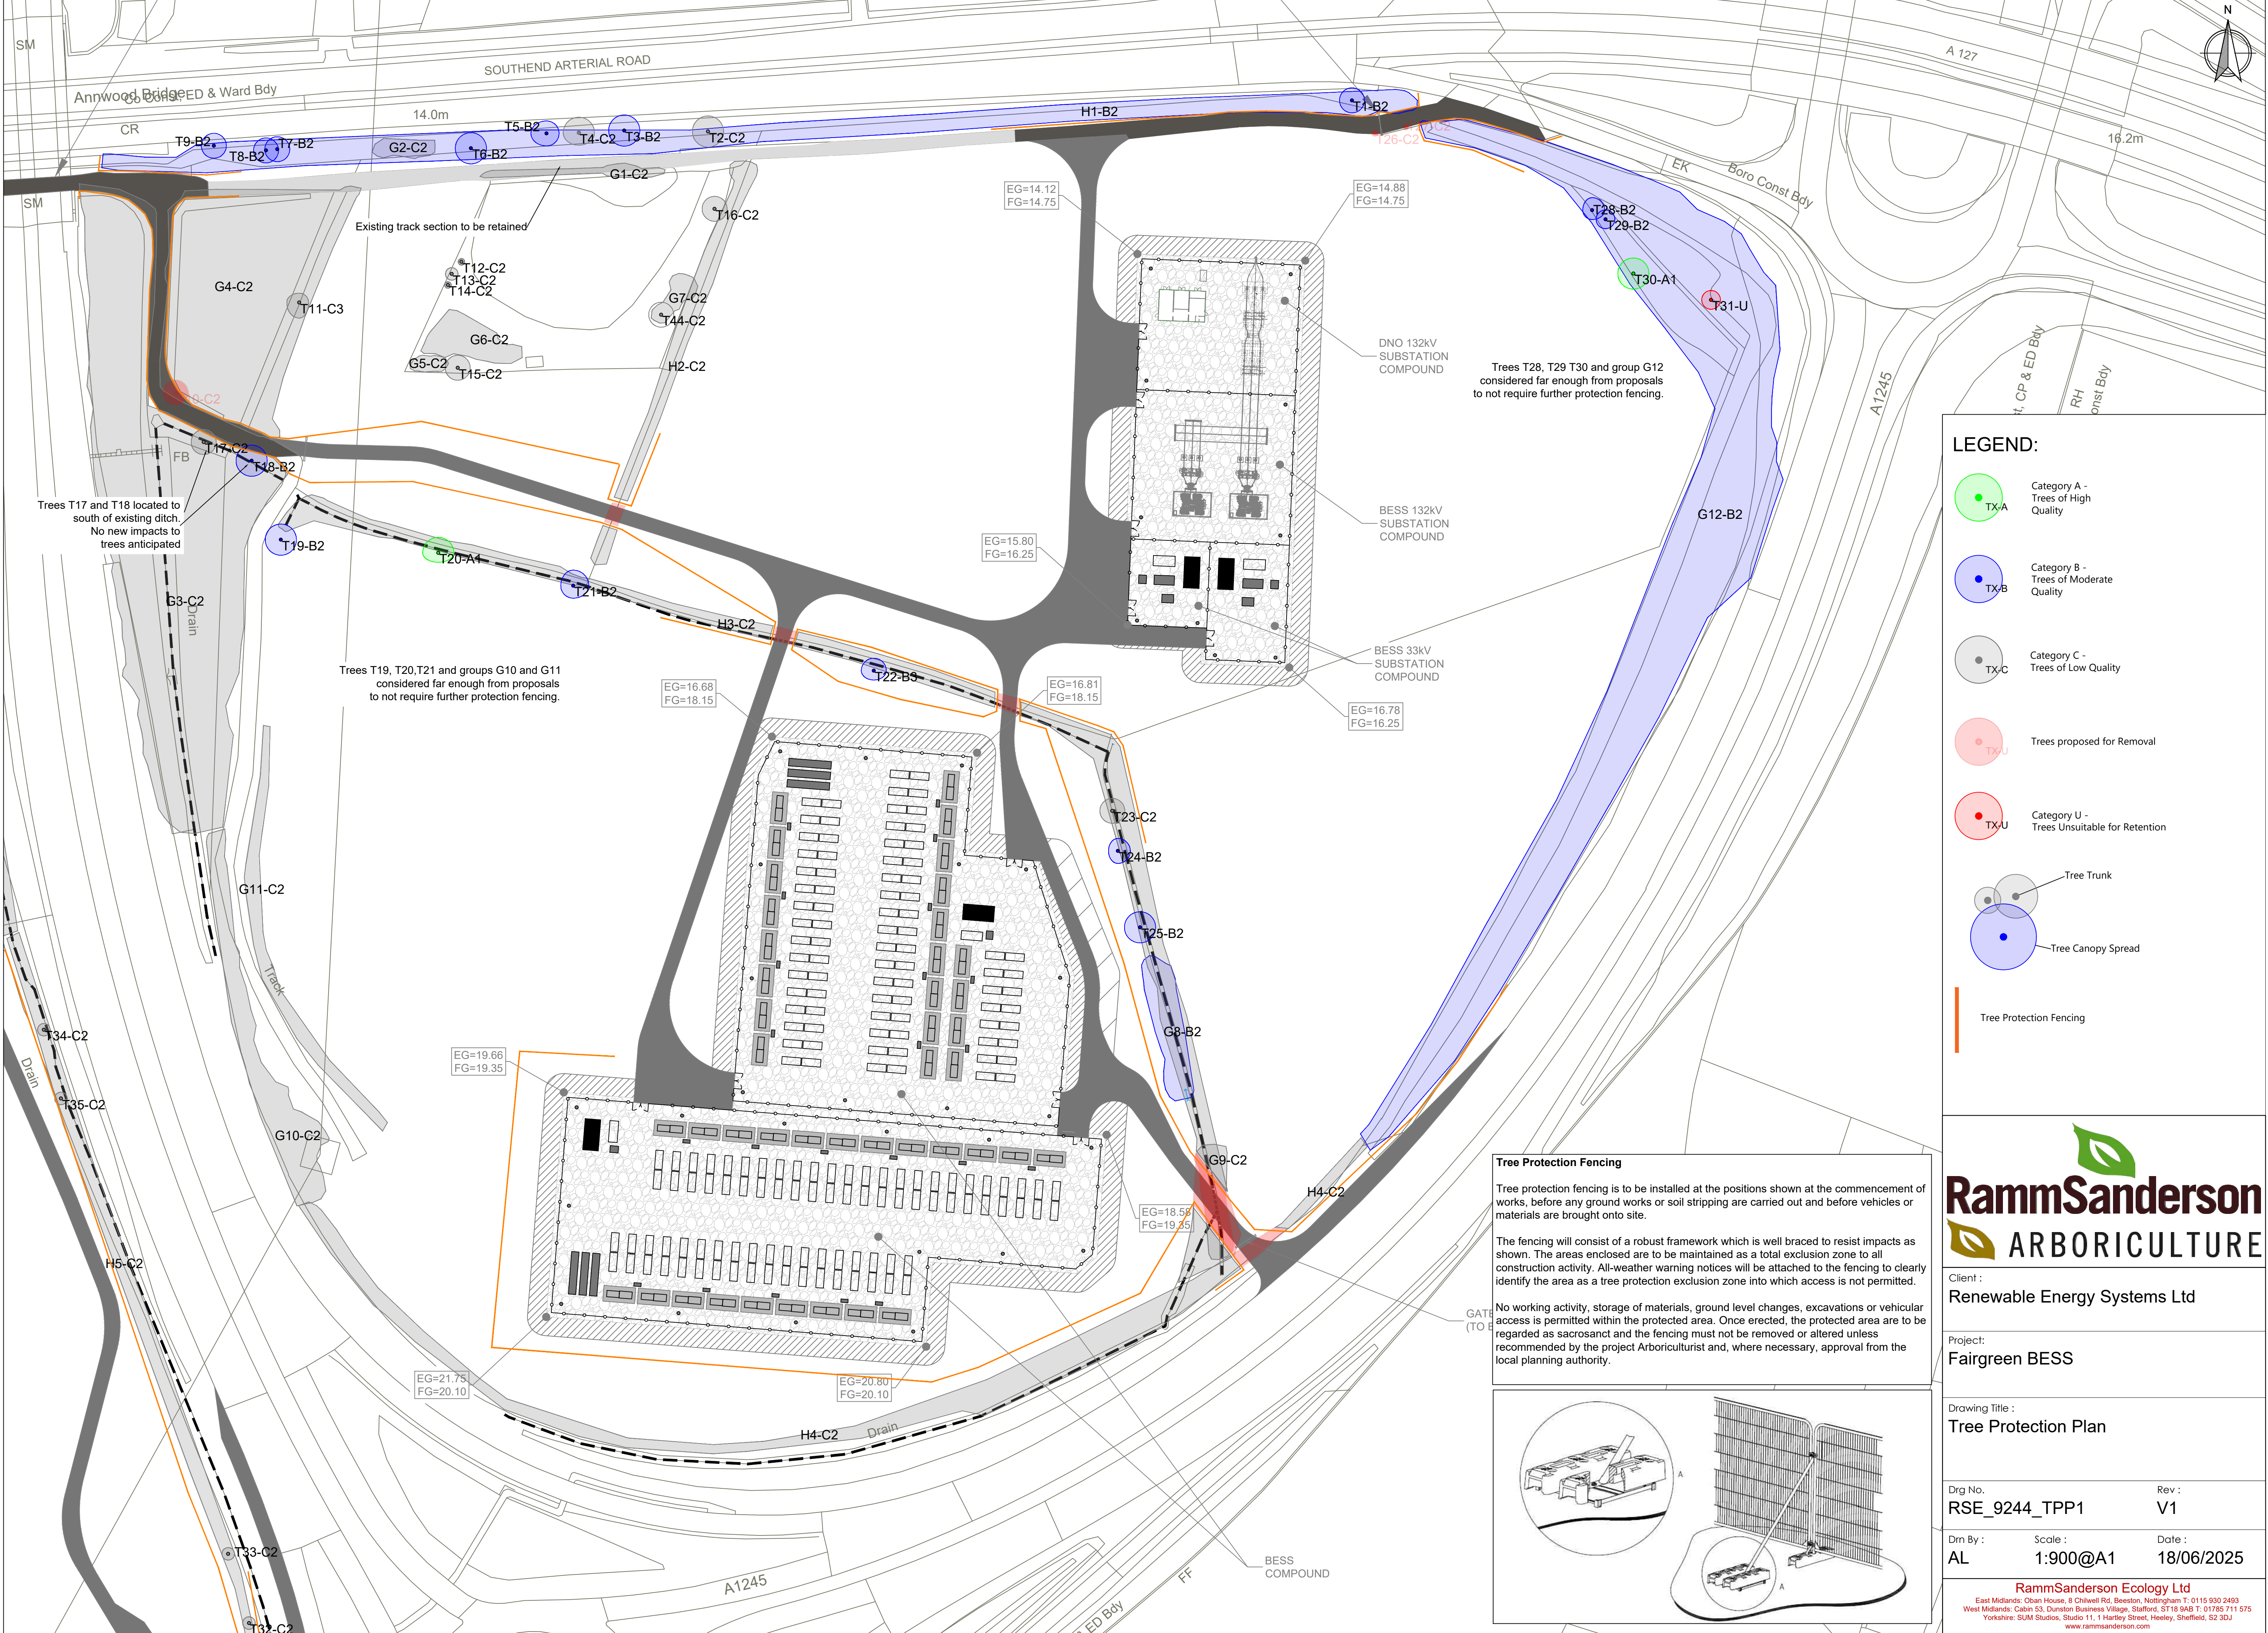
Drg No. RSE_9244_TPP1 Rev : V1
Drm By : AL Scale : 1:900@A1 Date : 18/06/2025

Trees T17 and T18 located to south of existing ditch. No new impacts to trees anticipated

Trees T19, T20, T21 and groups G10 and G11 considered far enough from proposals to not require further protection fencing.

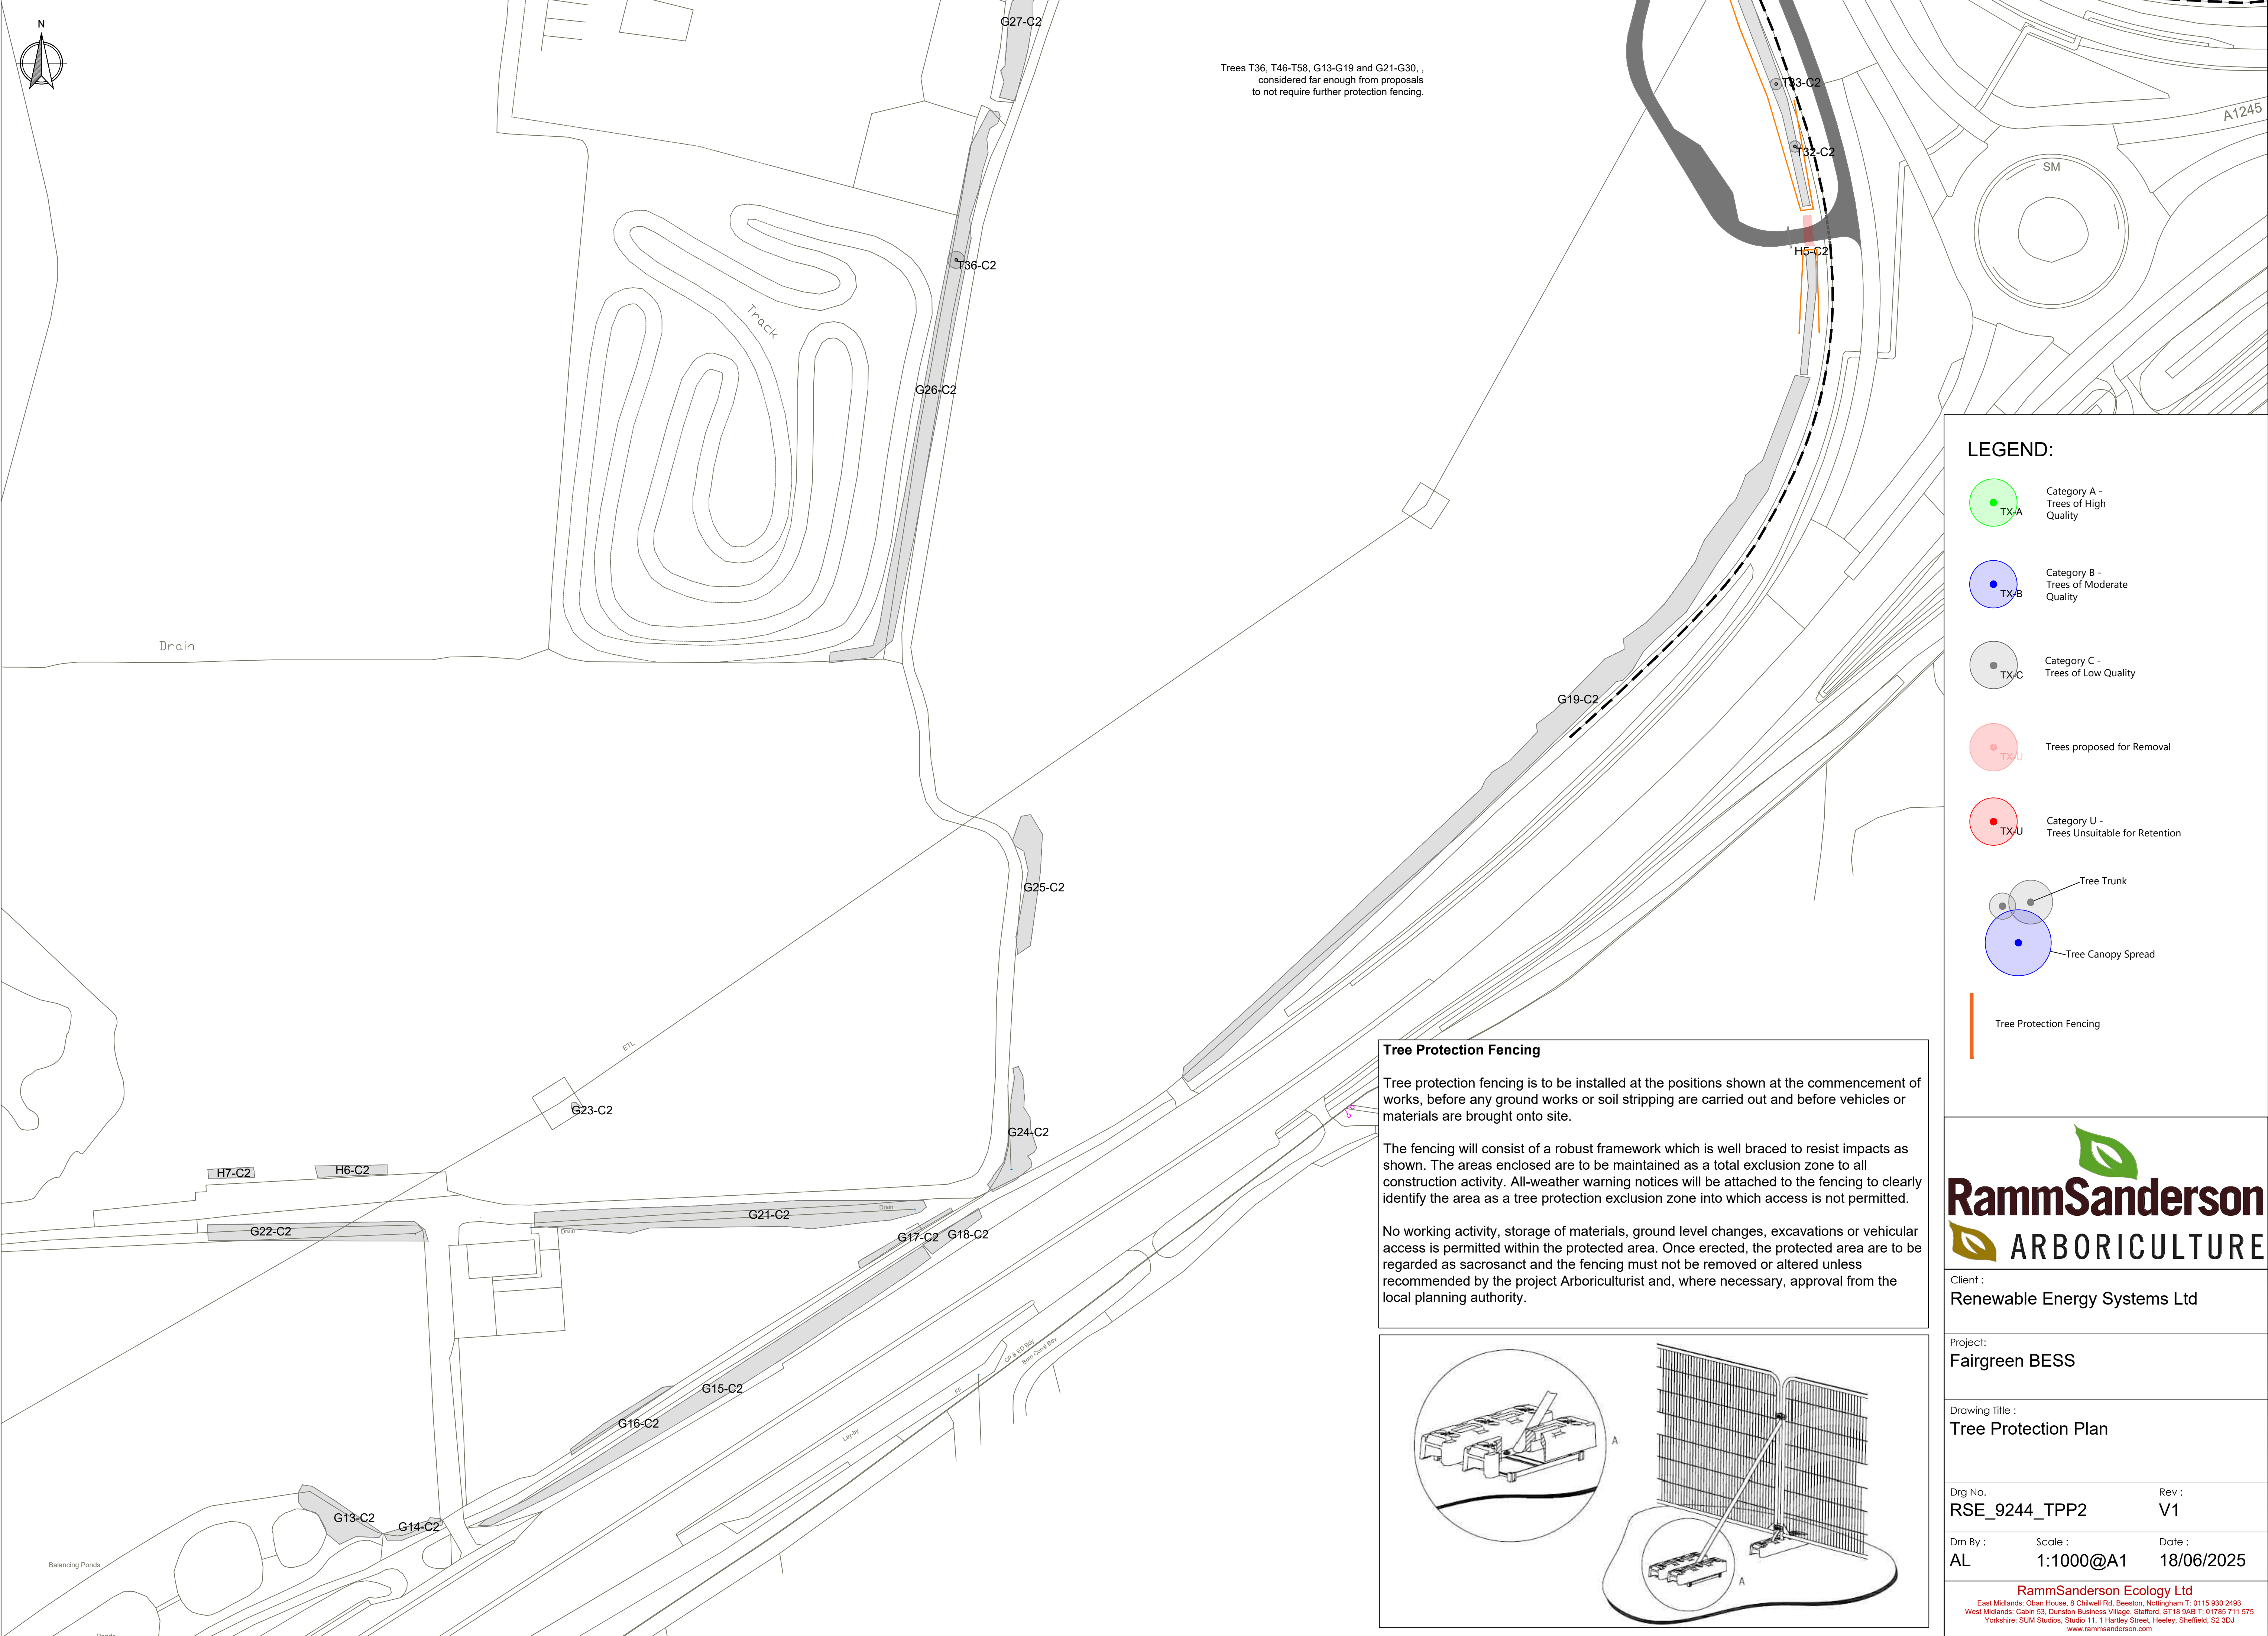
Drg No. RSE_9244_TPP2	Rev : V1
Drm By : AL	Date : 18/06/2025

Trees T36, T46-T58, G13-G19 and G21-G30, , considered far enough from proposals to not require further protection fencing.
